Lesson Learnt:

HSE – Non conforming Head Board

Lesson learnt Number : 004
Classification : HSE
Contact Person : Andrew Nkomo
Contact Phone : 08 9483 171739
Date : 27/08/14
Rev Number : 1

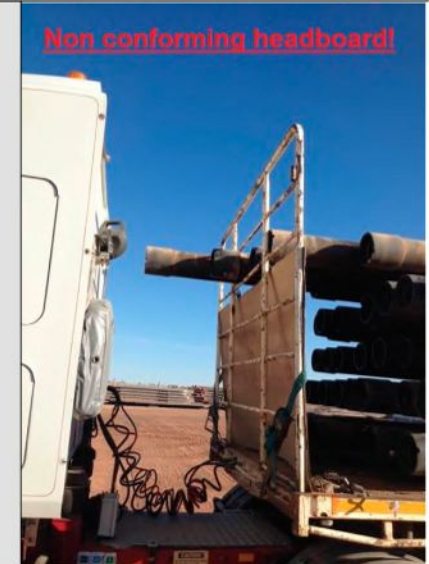
MITO yard received a delivery of casing and it was evident that the load had shifted forward. Because a non conforming Headboard had been used, the shifted pipe was in close proximity of the cab. In the event of harsh braking, that load could have shifted further forward penetrating the cab resulting in injury, death or damage to equipment. Whilst an effort was made to add ply headboard which acts to prevent such event, the load was higher than the ply installed & the ply was relatively thin to prevent the pipe breaking through. The headboard was also not reinforced which is not allowed but did not contribute to this incident.

- Procedure not clearly articulating Headboard requirements i.e use of reinforced headboard, sturdy backboard, adequate load restraint
- Loader not identifying potential hazard during the loading process in the yard.
- Driver not identifying potential hazard after loading process complete and checking load integrity.
- Shifting load during transit.

- All headboards must be suitable for the specific load requirements, there must be no chance of the pipe penetrating through the headboard.
- The collection point must not load the truck if headboards are not appropriate/damaged or fit for purpose
- Full load restraint must be adhered to for every load.
- Diameter of pipe is the key factor when dealing with reinforced headboards
- Joints should not be stacked higher than Headboard or headboard backboard
